A Garage Inspection

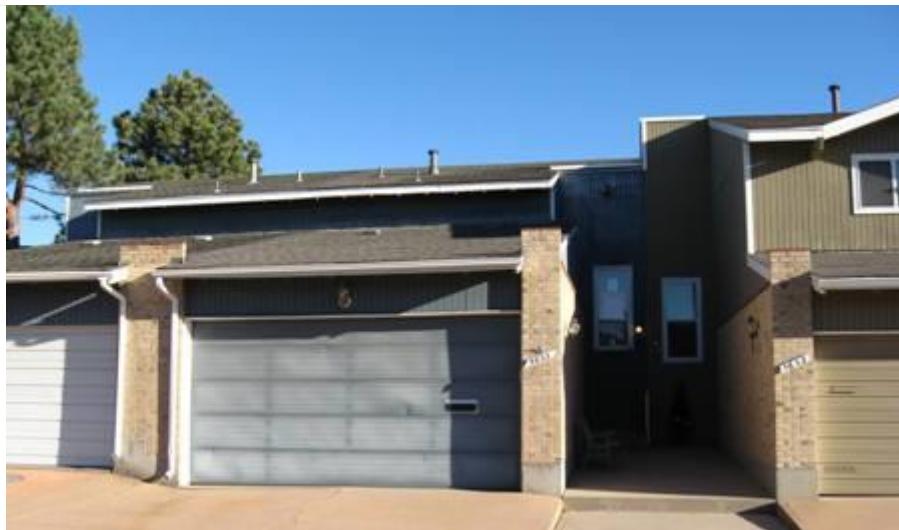
This is the exterior of a Town House garage that was inspected. During the inspection, a neighbour informed the Inspector that the roof of another garage, identical to the one pictured above two buildings down, had collapsed the previous winter under a snow load.

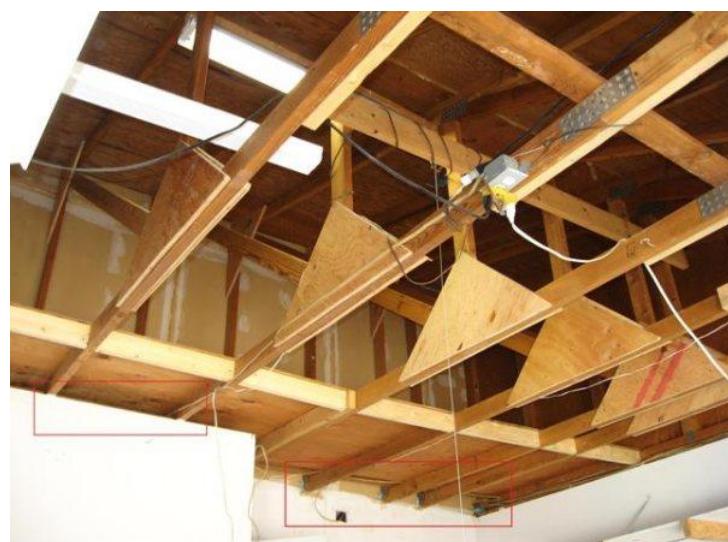
Above: trusses and truss connections

Some defects you must search for, and some are pretty obvious. These first two defects were obvious from the doorway:

- improper alterations; and
- improper bearing points.

Trusses may not be altered in any way without the approval of a structural engineer. When you see plywood gussets added at truss connections like these triangular gussets, then an alteration of some sort has obviously been made and you have to recommend evaluation by a structural engineer.

Trusses are designed to bear loads at very specific points. Typical roof trusses should not touch any interior walls and should bear only on the exterior walls. The two trusses at the left of the above photo are bearing on an offset portion of the garage wall.

A portion of the structural roof load was being transferred to the bottom chords of the trusses at a point at which they were not designed to support a load.

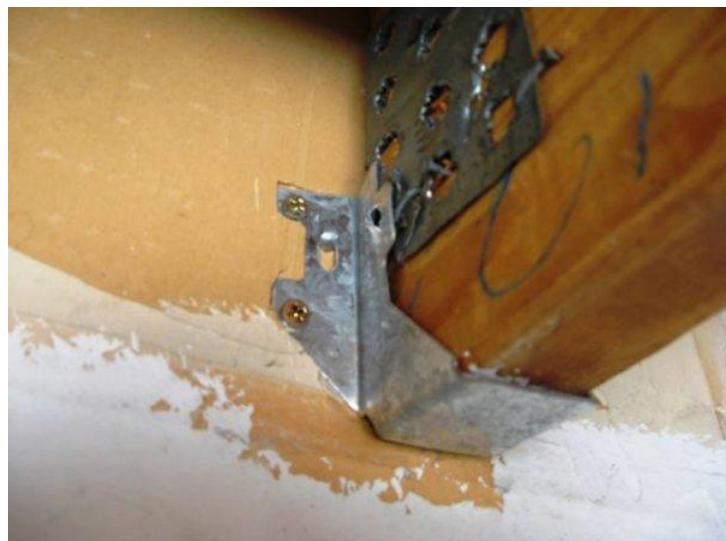
Above: the connection

The Inspector walked over and looked more closely at the connections where the trusses attached to the wall and found these problems:

- inadequate metal connector (hanger);
- inadequate fasteners (deck screws); and
- improper fastener installation (through drywall).

These trusses would have best been supported by bearing directly on wall framing. The next best solution would be an engineer-designed ledger or engineer-specified hardware. And that may have been how they were originally built, but by the time the Inspector inspected them, 24-foot roof trusses were supported by joist hangers designed to support 2x4 joists. The hangers were fastened with four gold deck screws each.

Gold deck screws are designed to resist withdrawal. Fasteners for metal connectors such as joist hangers are designed to resist shear.

So, there were drastically undersized metal connectors fastened by badly under-strength fasteners.

To make matters worse, the screws were fastened through drywall, which doesn't support the shaft of the screw and degrades the connection even further.

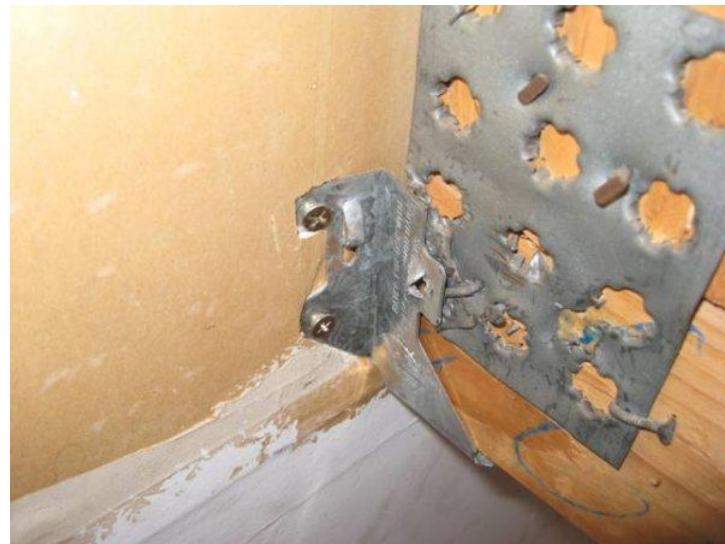
Above: gang-nail integrity destroyed

Once the Inspector looked closely, he found more truss alterations. The gang-nail had been pried loose and the spikes which form the actual mechanical connection were destroyed. In their place were a couple of bent-over nails. This condition represented a terrific loss of strength and this roof, too, was a candidate for catastrophic structural failure.
